State of Oregon
Department of Environmental Quality

Memorandum

Date: July 19, 2007

Subject: Recommendation for No Further Action,
Paco Pumps ECSI # 146

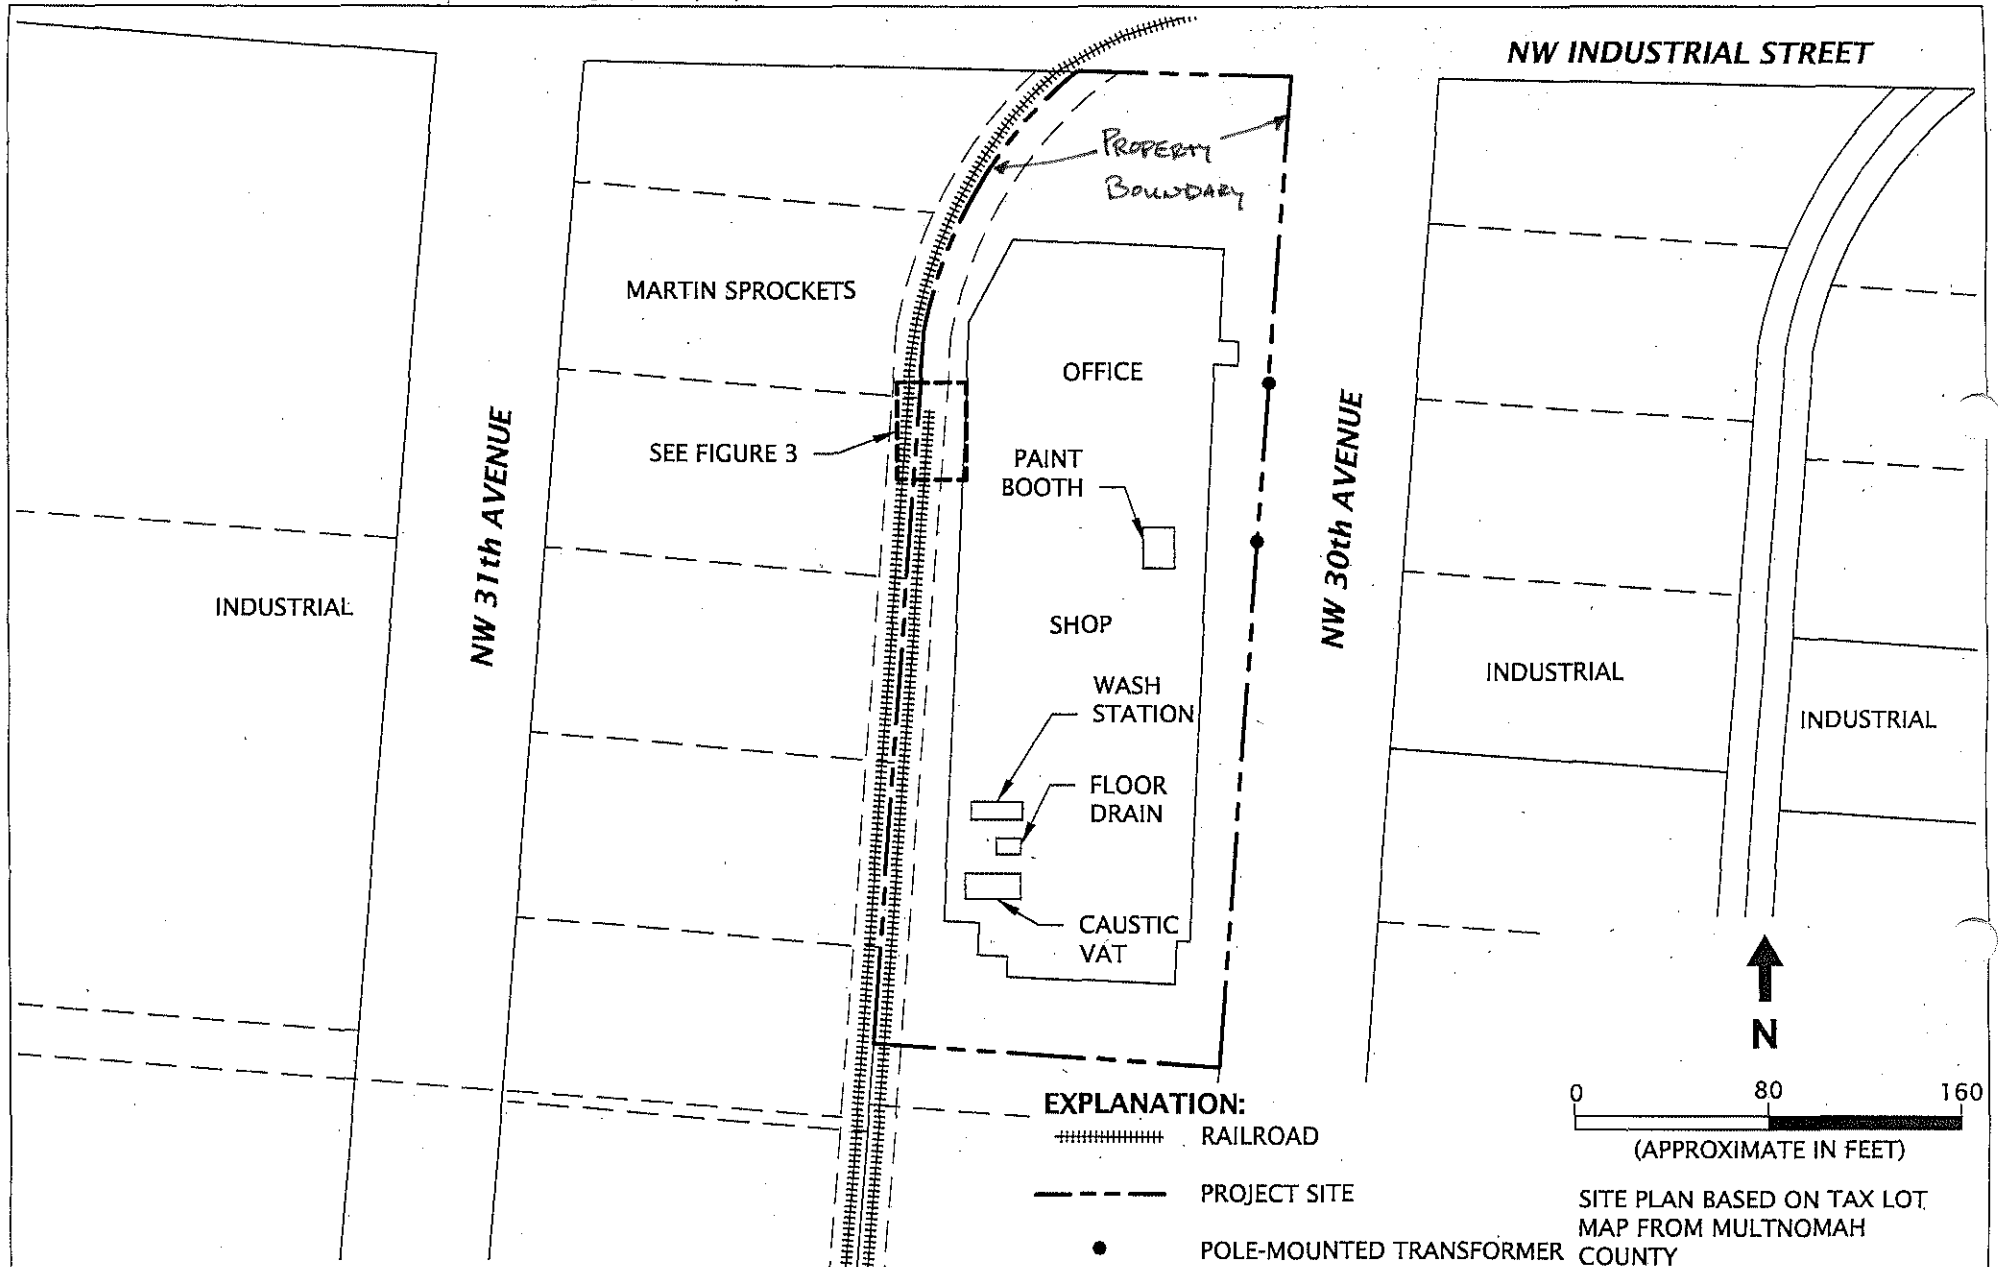
FIGURE 2

The site was undeveloped prior to operations of the Pacific Pumping Company which began as early as 1956. Paco Pumps purchased the property in 1986 and performed the same operations as Pacific Pumping Company, which entailed pump assembly, pump rental, and pump servicing. Operations included an office, paint booth, shop, and washing station and service area for pumps (as shown on attached Figure 2).

Until mid-1995, when the facility upgraded its wash water collection and disposal practices, there were two metal-lined sumps in the southwest part of the building (in the vicinity of the wash station and floor drain shown on Figure 2). One of the sumps collected washwater from pump cleaning and discharged the water to the City sanitary sewer. The second sump was filled with water to pressure test pumps and had no drain or outlet (there is no documentation for how wastewater was managed). A third sump located further north in the shop pump assembly area, collected wastewater from the testing of new pumps, and formerly discharged through a pipe that penetrated the west wall of the building and onto the ground surface outside the building (see attached Figure 3). After 1987 the sump discharge was re-routed to the sanitary sewer. In 1995 Paco Pumps upgraded the interior of the facility and made improvements to their wastewater management practices. They filled in and concreted over the wash and test sumps and routed wastewater through a new oil/water separator (located in the same area) which discharged into the City sanitary sewer.

- As part of the facility improvements in 1995, petroleum contaminated soil was excavated beneath the concrete floor of the building where cracks in the concrete had allowed petroleum to migrate through to underlying soil. This work was completed in the wash station area (shown on Figure 2). Following the removal of approximately 1 foot of soil, confirmation samples were collected and analyzed with results of 15 mg/kg, 20 mg/kg, and 20 mg/kg total petroleum hydrocarbons (TPH) by Method 418.1. No PCBs were detected and the tests were non-detect for RCRA metals by TCLP.

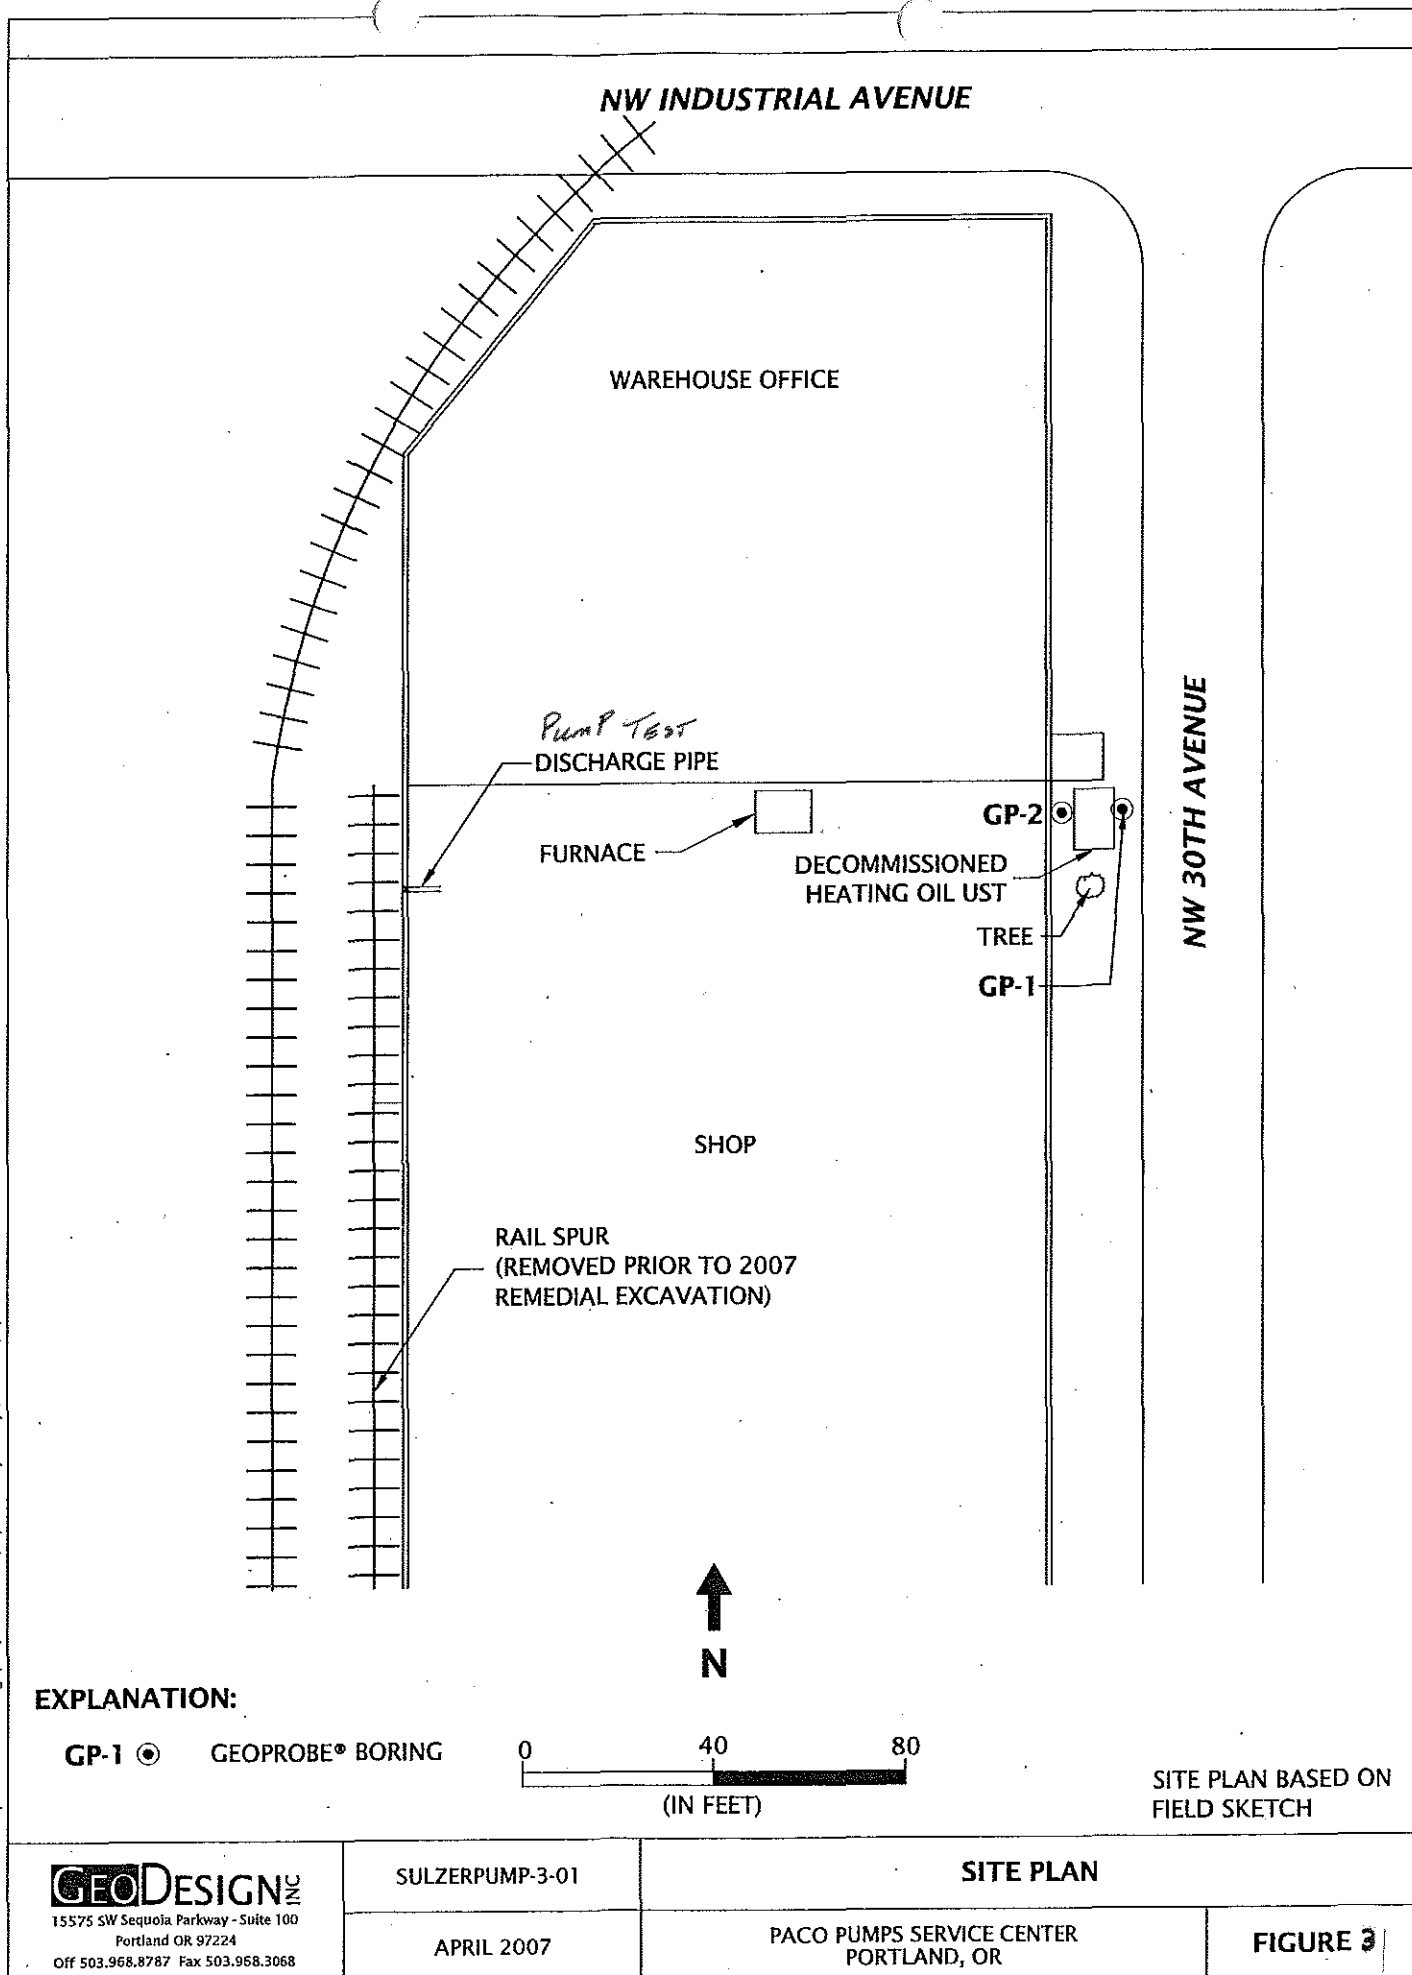
- In 2006, GeoDesign used the results of a geophysical survey to locate a heating oil underground storage tank (UST) east of the building office (as shown on Figure 3). The UST had been previously decommissioned in place by filling with concrete slurry in 1993. GeoDesign completed two soil borings at either end of the UST. No field indications of contamination were observed on soil in the two borings. Testing included sheen testing, headspace vapor readings, and visual and olfactory evaluations to a depth of 15 feet in the borings. Two soil samples from 9 to 10 feet depth were analyzed for total petroleum hydrocarbons with nondetectable results.

In January 2007, GeoDesign removed an additional 17.97 tons of soil from the contaminated area. GeoDesign estimated that the depth of PCB impacts were limited to approximately 1 foot, but excavated to 1.5 feet below ground surface as a conservative measure. PCBs were not detected in any of the post-removal soil confirmation samples collected at depths of 0.5 to 1.0 feet and 1.5 to 2.0 feet. Detection limits ranged from 0.0796 mg/kg to 0.0847 mg/kg. The PCB soil concentrations outside of the removal area ranged from nondetect to 0.457 mg/kg. Only PCB Aroclors 1254 and 1260 were detected (attached Figure 3).

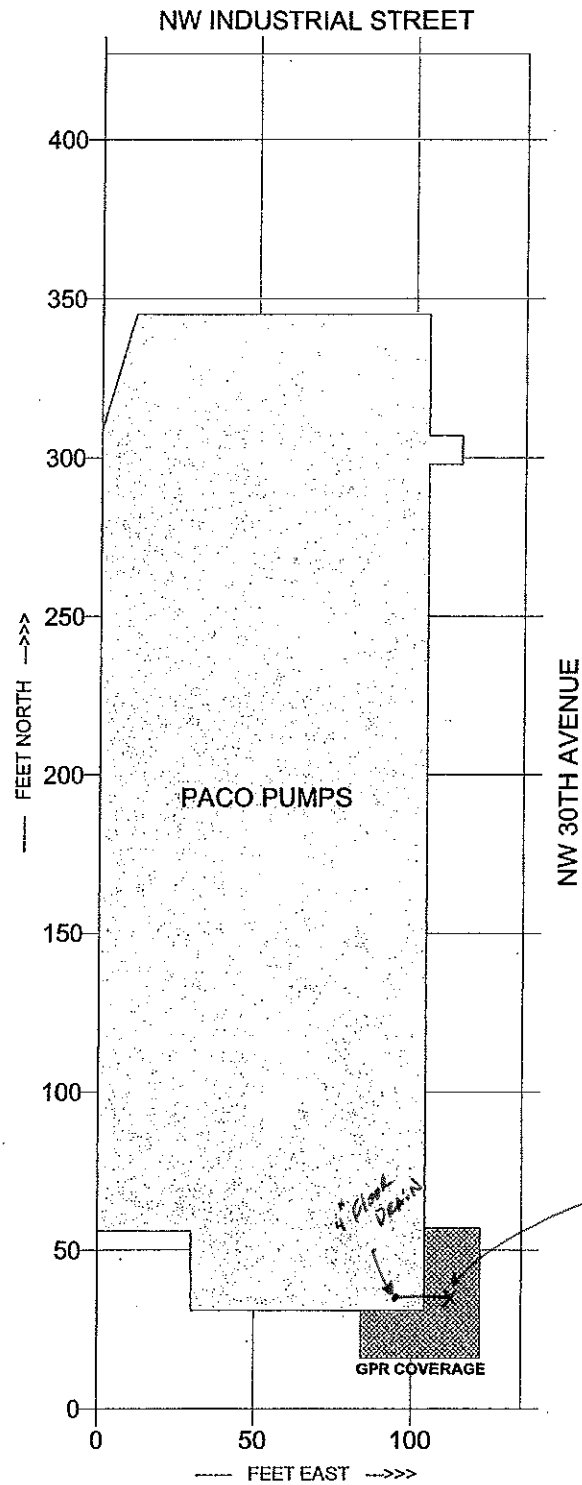
- A City of Portland plumbing record dated 1952 indicates the presence of a dry well outside the southeast corner of the building. The plumbing record shows the dry well located 12 feet to the east of an interior floor drain (attached Figure 5). In 2006, GeoDesign subcontracted for a geophysical survey at the site to search for the potential dry well and a decommissioned underground storage tank (next bullet item below). No indications of a dry well were observed; in addition, during utility work for site redevelopment there has been no observed surface or subsurface features indicating a dry well in the area. The interior floor drain shown on the plumbing record, which likely discharged to the City sewer, has been sealed as part of current building reconditioning.

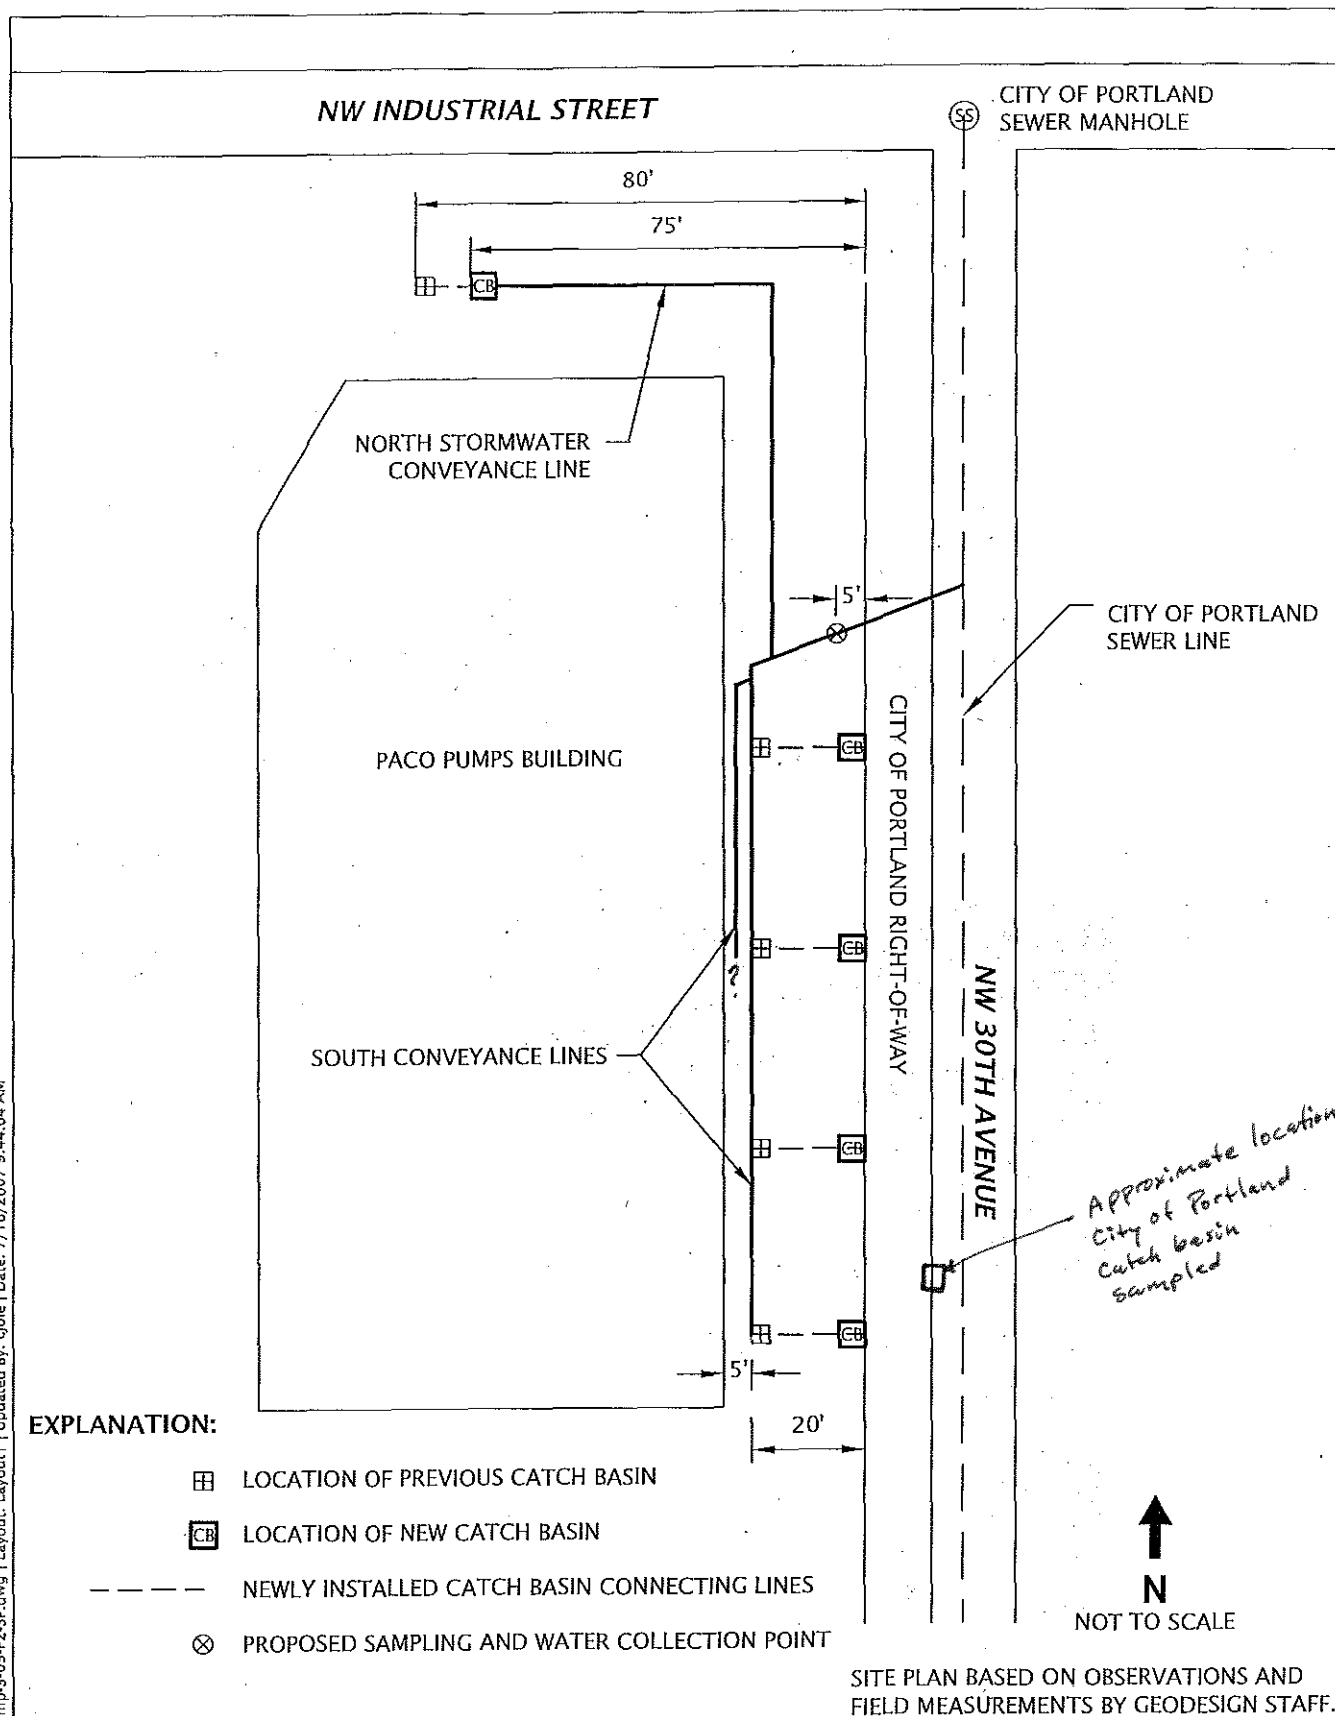
FIGURE 6

City industrial stormwater inspectors previously indicated that sheet flow from a small area in the southeastern portion of the site drained to a catch basin in the City right-of-way. In May 2007 the City and DEQ sampled a catch basin in the City right-of-way adjacent to the southeast corner of the site (Figure 6). Samples were analyzed by the City Water Pollution Control Laboratory with contaminant detections that included 0.271 mg/kg Aroclor 1242, 0.143 mg/kg Aroclor 1260, 6.70 mg/kg Bis(2-ethylhexyl) phthalate, 1990 mg/kg copper, 813 mg/kg lead, and 16600 mg/kg zinc. The presence of contaminants in a catch basin off the southeast corner of the facility, including Aroclor 1242 which was not detected in on-site soils, is not consistent with known historical operations of the Paco Pumps facility. It is not clear to what extent past Paco Pump operations or current development activities may have contributed to contaminants detected in the catch basin solids. Contaminants detected in the catch basin could equally be attributed to runoff from the NW
